## Locomotive Engine Cranking Abutment Prevention

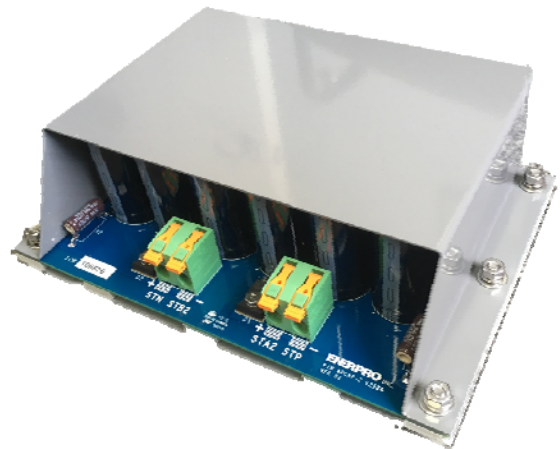
Several years ago, Enerpro engineers realized that a large capacitance in parallel with the pull-in coil is much more effective than the 0.32 ohm resistor in producing a short duration armature current pulse. This high amperage pulse substantially increases the motor speed at the instant that the pinion gear abuts with the ring gear. Tests have shown that this simple addition effectively cures the sticking abutment problem.
